COASTAL SLOPES – PLANNING POLICY

APPROVED BY EXECUTIVE COUNCIL SEPTEMBER 2nd, 2004

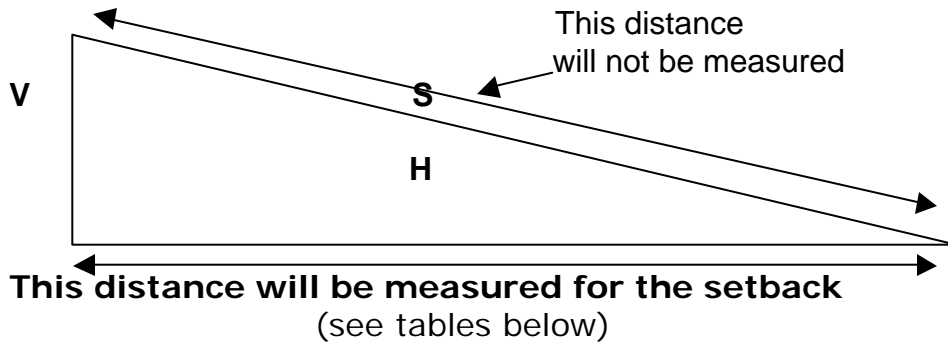
These will be measured horizontally (and not measured along the slope)

Examples of setback slopes for distance of 80 feet, 100 feet and 110 feet.

Horizontal Distance	Slope Distance	Vertical Height	Horizontal Distance	Slope Distance	Vertical Height	Horizontal Distance	Slope Distance	Vertical Height
H	S	V	H	S	V	H	S	V
80	80	0-5 feet	100	100	0-5 feet	110	110	0-5 feet
80	81	5-10 feet	100	101	5-10 feet	110	111	5-10 feet
80	83	15-20 feet	100	102	15-20 feet	110	112	15-20 feet
80	84	20-25 feet	100	103	20-25 feet	110	113	20-25 feet
80	85	25-30 feet	100	104	25-30 feet	110	114	25-30 feet
80	87	30-35 feet	100	106	30-35 feet	110	115	30-35 feet
80	89	35-40 feet	100	108	35-40 feet	110	117	35-40 feet
80	92	40-45 feet	100	110	40-45 feet	110	119	40-45 feet
80	97	50-55 feet	100	114	50-55 feet	110	123	50-55 feet
